Manhole Inspection Summary

Manhole # S35MM_019MH

Insp Date: **3/6/07 9:21 AM**

Location Address: **337 22ND ST**

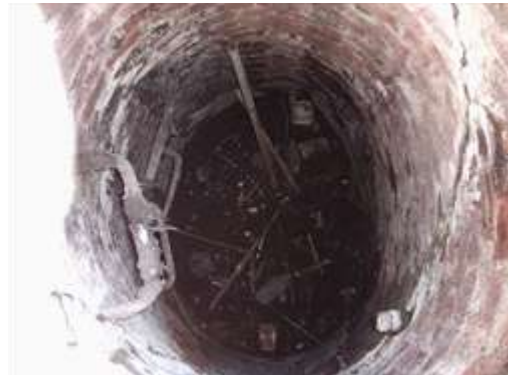
Top View

Channel debris.

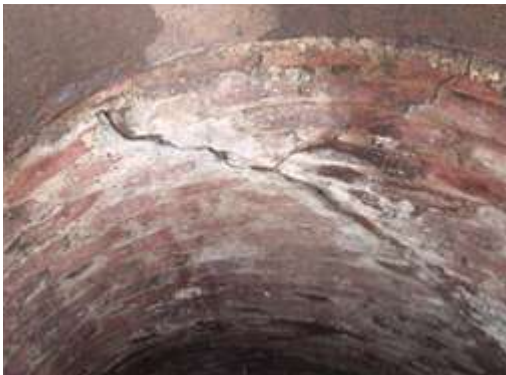
Defect

Condition: ☐ Sound ☒ **Cracked** ☐ Root Intrusion ☐ Loose Brick ☒ **Deteriorated**

Infiltration: ☐ None ☒ **Joint** ☒ **Cracks** ☐ Mortar ☐ Roots ☒ **Wall**

Infiltration: ☐ None ☐ Joint ☐ Cracks ☐ Mortar ☐ Roots ☒ **Wall**

Frame leaks. Corbel deterioration, cracks, and infiltration. Barrel infiltration.

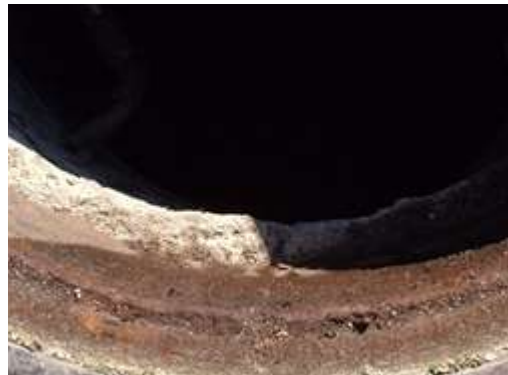
Defect

Frame Offset: **1** (in.)

☒ **Leaks**

Frame leaks. Frame offset.

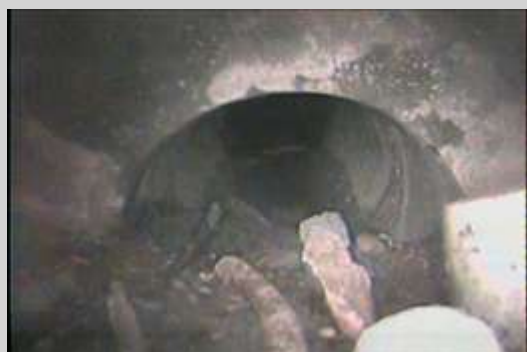
8 in. Circular Gravity Sewer

Pipe Out @ 12 O'Clock

Deposits: ☐ None ☒ **Mud** ☐ Sludge ☒ **Debris** ☐ Grease

Silt Depth: **2** (in.)

Infiltration: **Evidence**
